LOWER BEAVER POND DAM

CHESTERFIELD COUNTY, VIRGINIA

VA. NO. 04106

# PHASE I INSPECTION REPORT

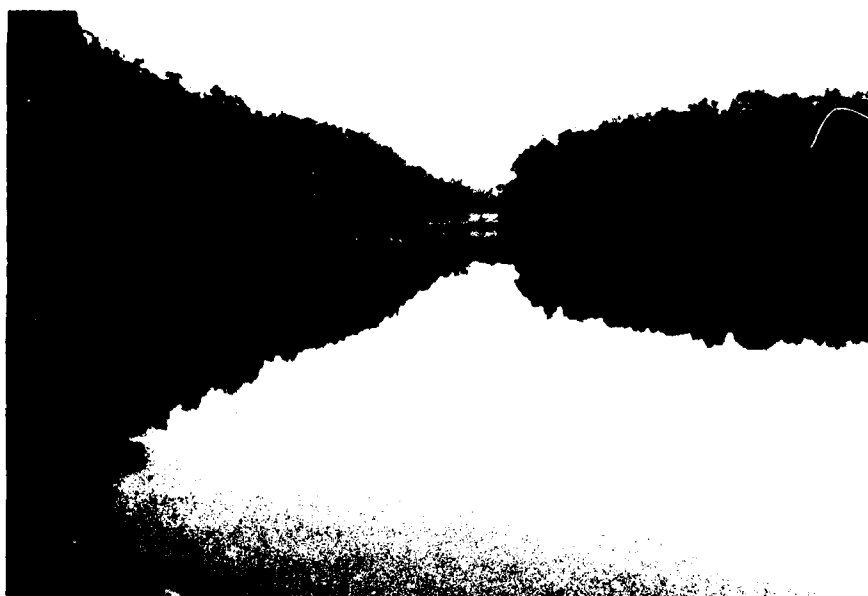
3.1.3 Reservoir Area: The reservoir area was free of debris and the perimeter was wooded (Overview Photographs, Page 5). The reservoir is located in a valley with side slopes at approximately 3H:1V. No sediment build-up was observed.

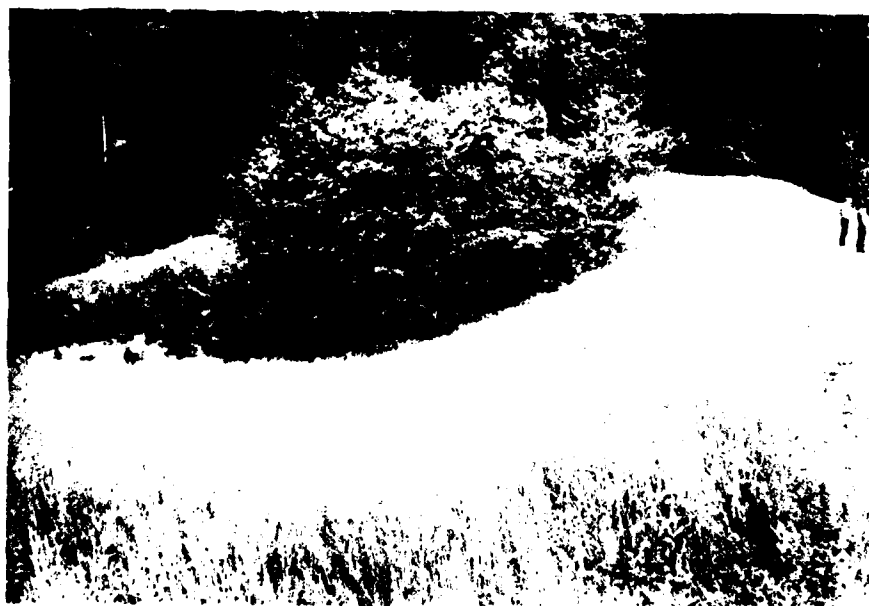
Photo No. 2

Downstream face of dam

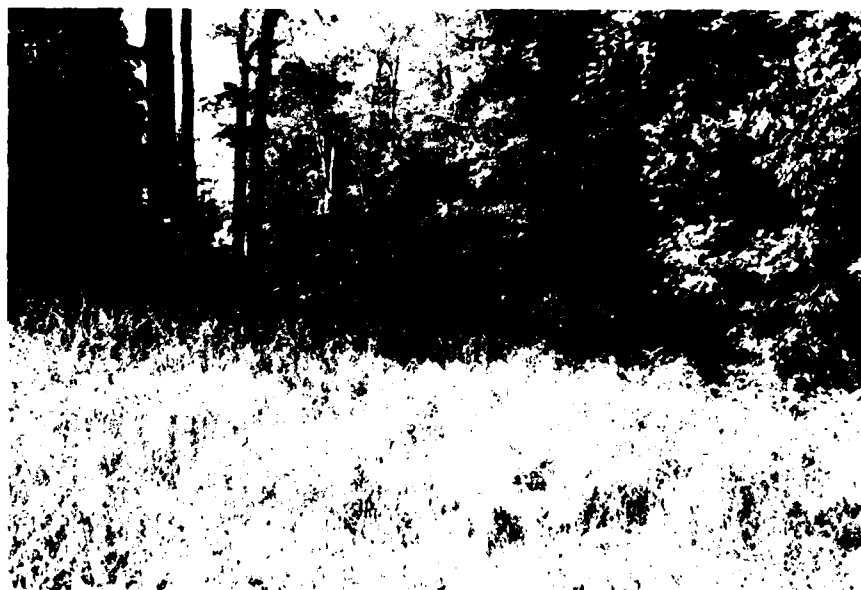
Photo No. 6

Downstream Channel  
(Arrow Denotes Channel)

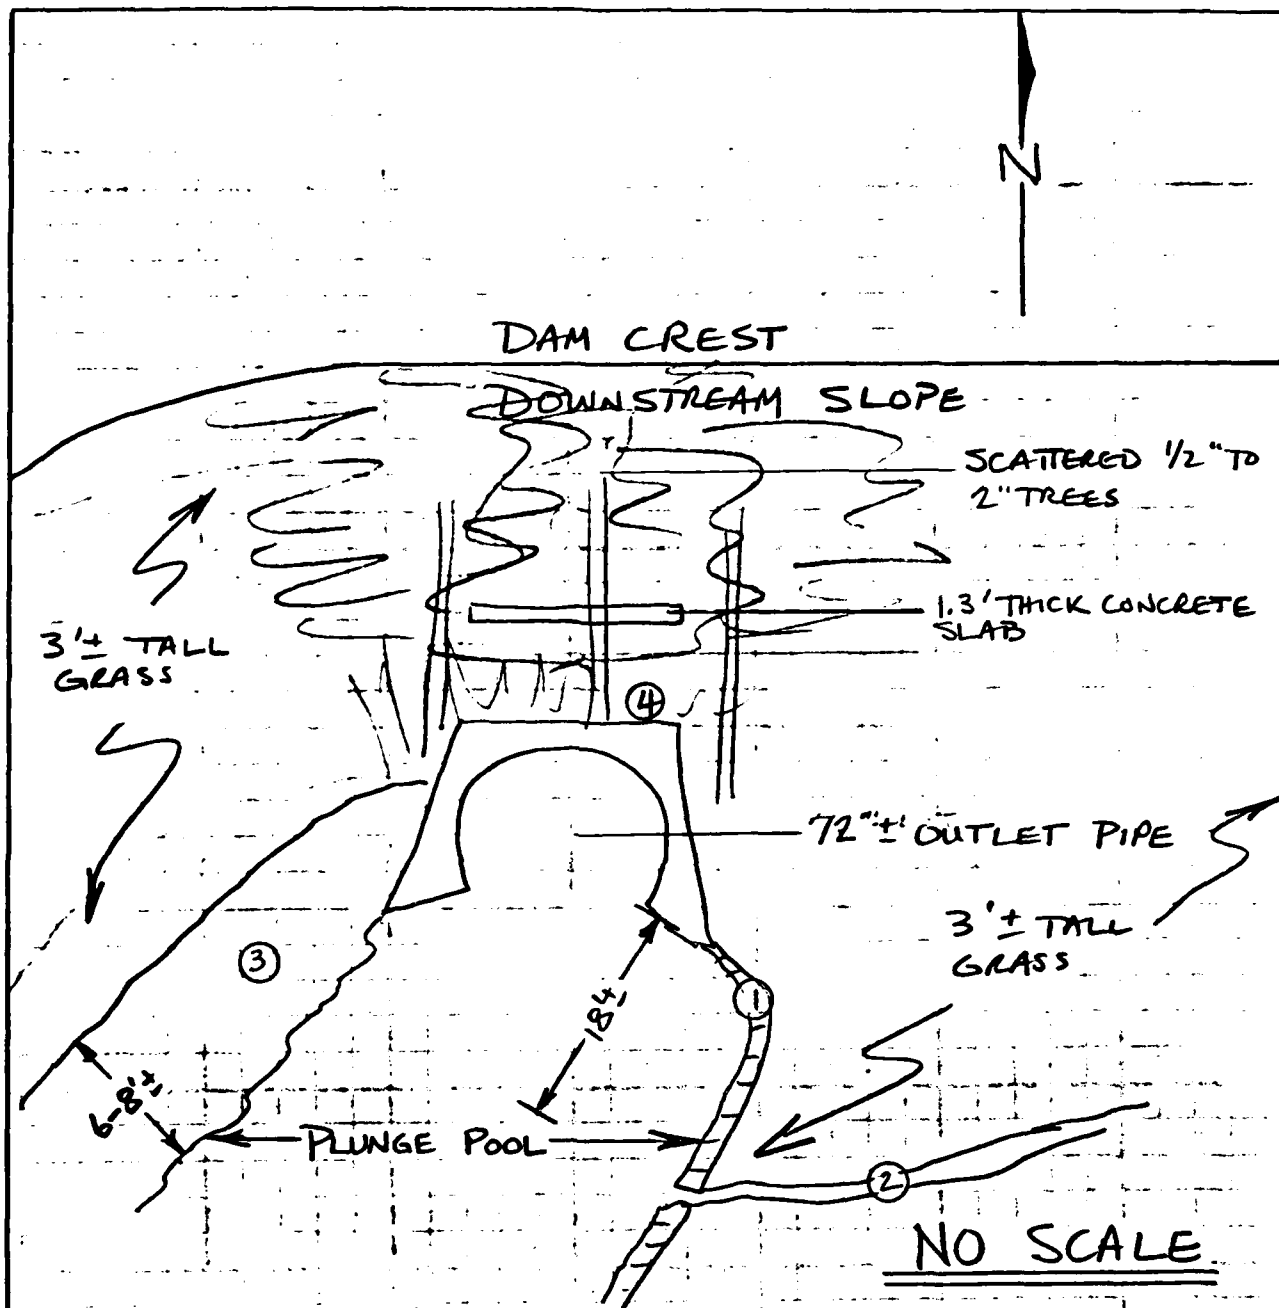
SUBJECT FIELD SKETCH OF ERODED AREAS

The only surface erosion noted on the embankment exists along the left downstream slope as shown on Sheet 1 of Appendix III. A 65 to 75 ft± long erosion gulley, which is about 1 to 2 ft wide and 1 to 3 ft deep, developed as a result of extremely heavy rainfall in October, 1979. No seepage was observed along the downstream slope.

- ① 1' TO 3' ± DROP FROM EDGE OF SLOPE TO POOL
- ② EROSIONAL GULLEY 1' TO 2' WIDE AND 1' TO 3' DEEP. EXTENDS 65' TO 75' ± UPSLOPE TOWARD THE LEFT ABUTMENT
- ③ BARE, VERY STEEP SLOPE WITH SCATTERED SURFACE WASHING
- ④ SOIL AND BOULDERS (UP TO 5' ± LONG) FILL OVER TOP OF OUTLET STRUCTURE. SEVERAL ANIMAL BURROWS PRESENT

7.3.5 Animal burrowing observed above the outlet structure should be prevented. Existing holes should be backfilled with compacted soil.
